Winscar Reservoir – a case study membrane repairs to a leaking reservoir

by J R Claydon, BSc(Eng), ACGI, DMS, FICE, All Reservoirs Panel Engineer

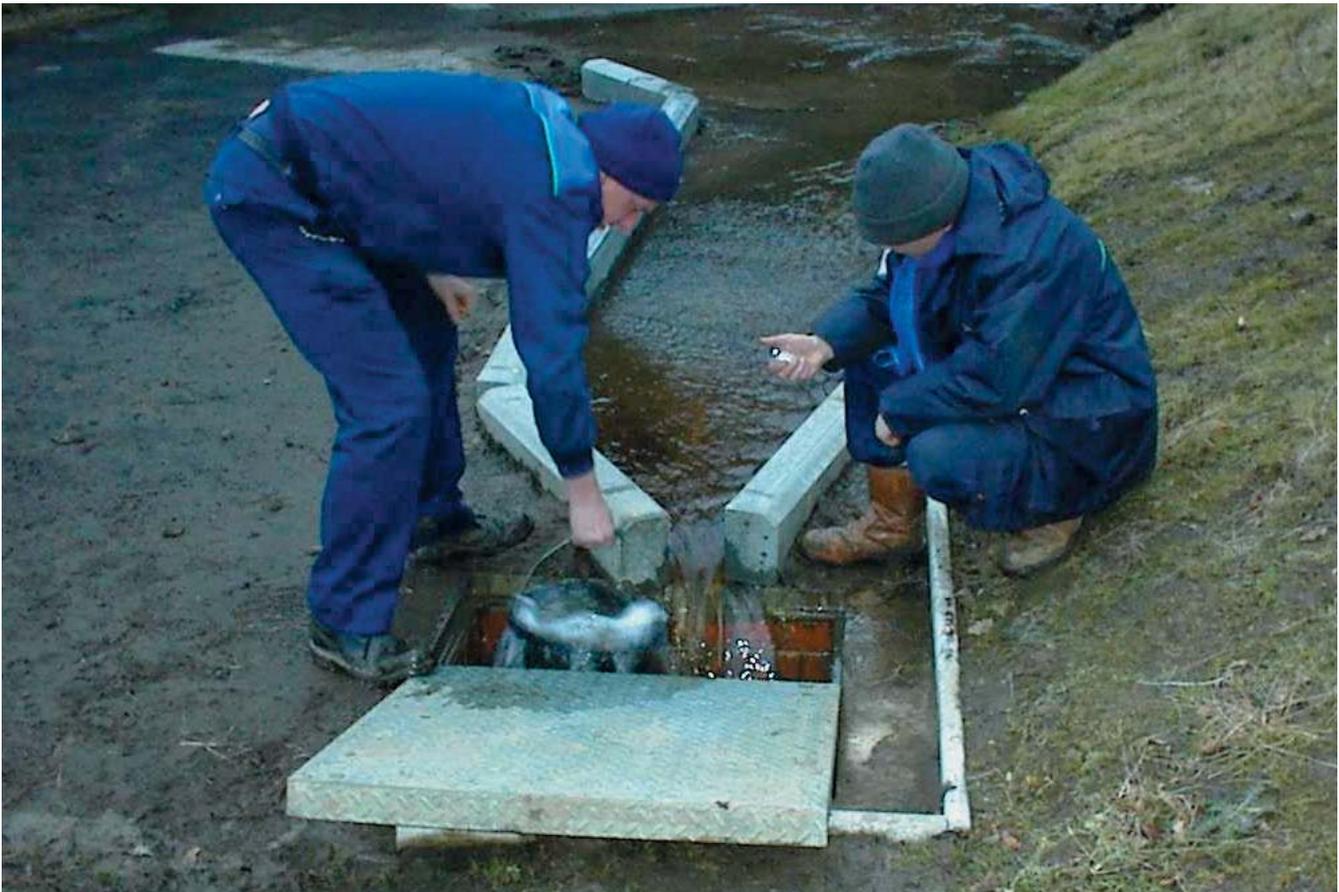
Winscar Jan 2001-leak measurement by stopwatch (courtesy Yorkshire Water Services Ltd)

In January 2001 a large spring issued from the toe of the dam with a flow of about 15 litres/second. The reservoir was drawn down as a precaution and the response of seepage flows was closely monitored. Flow reduced at approximately half-depth of the reservoir, suggesting a major defect at this level.
