Glan Usk, Crickhowell

remedial works to slope damage

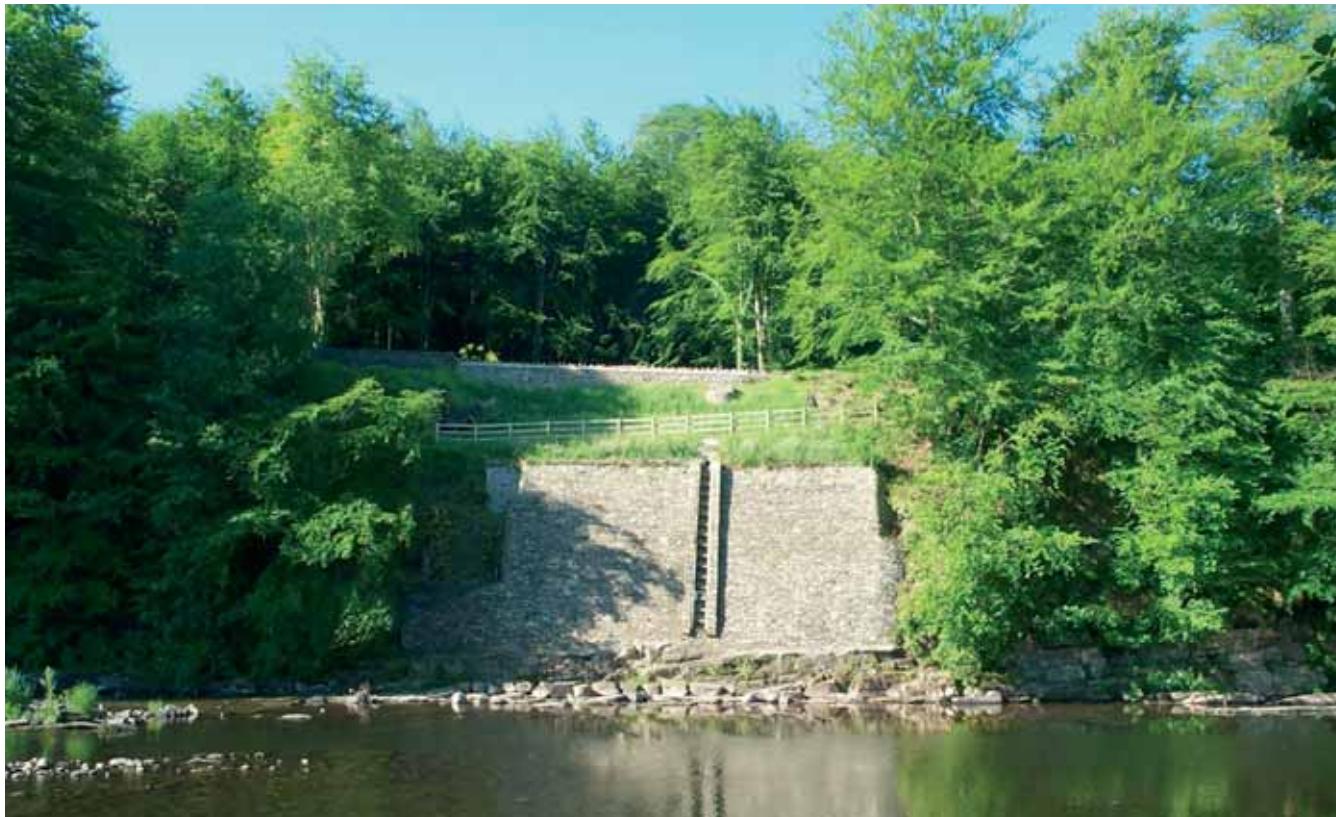
Glan Usk: Photo shows finished remediation work

A final solution comprised a lower, masonry faced, anchored concrete block revetment with an upper, wrap around, reinforced earth embankment. It was a 'one off' design, utilising original design features, such as producing concrete blocks required for the build 15km from the site at AMEC's pre-casting yard.

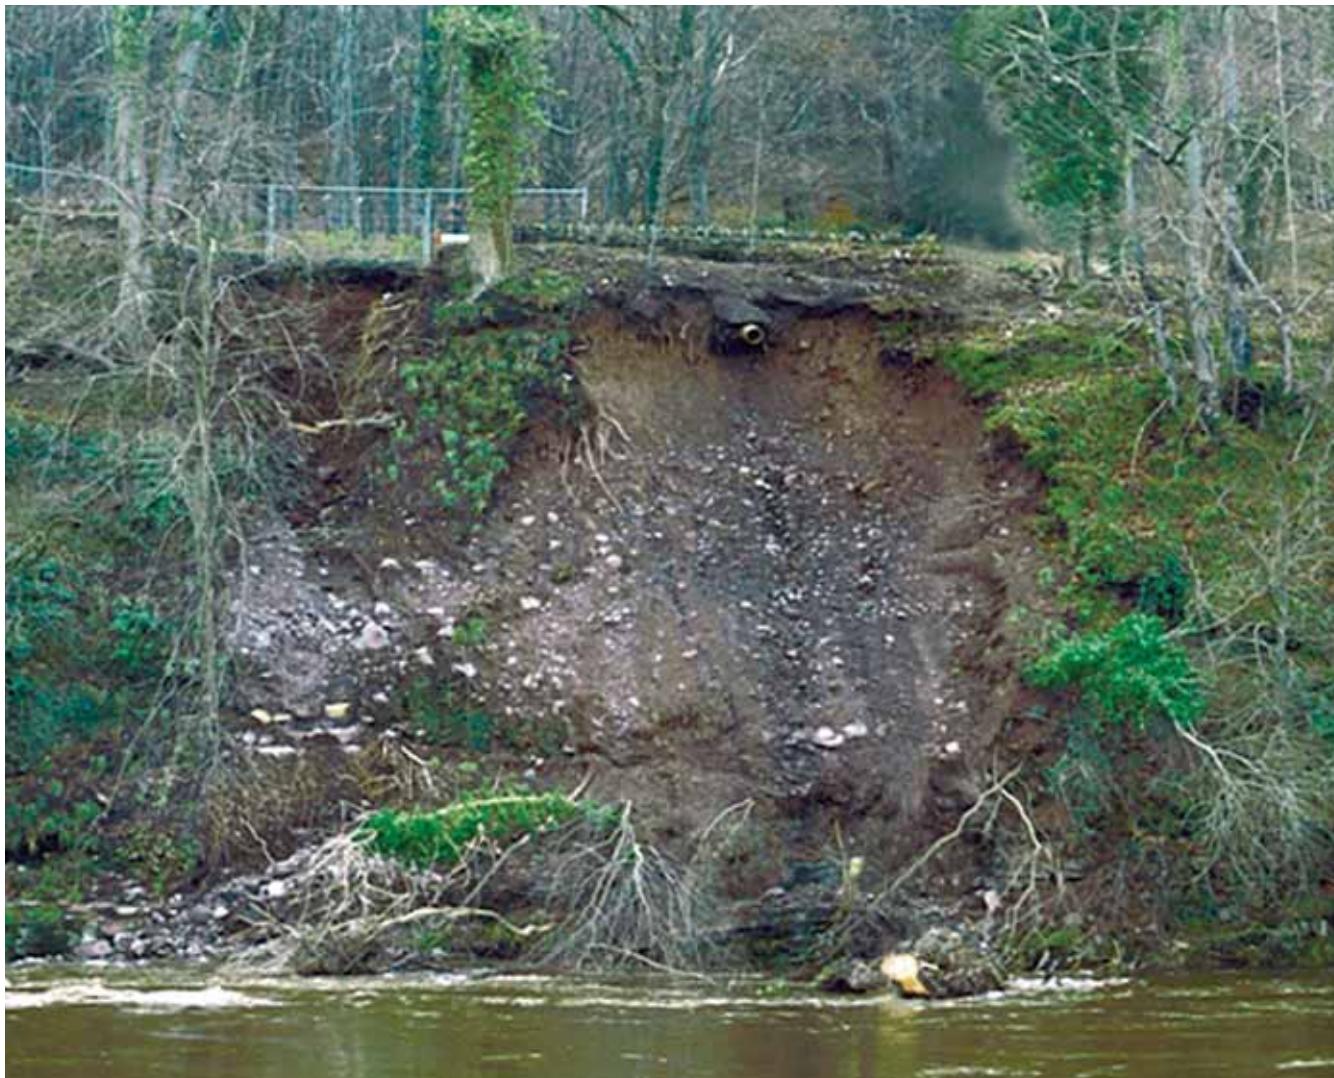
In December 2002, a 700mm diameter cast iron water pipe failed at Crickhowell (Brecon Beacons National Park); a mass of water was released onto the local trunk road, the B4558, scouring through the steep wooded slope located between the road and the River Usk. The damage had a significant impact on accessibility for local residents and trade, as a route connecting Llangynidr and Crickhowell had to be closed immediately. The River Usk also suffered from the mass of eroded soil and debris from boulders and trees. The remedial solution needed to be sensitive to the beauty of the Usk Valley and to safeguard the natural environment.

Glan Usk: Water pipe failure
