# Alnwickhill Clearwater Tank Repairs

## rectifying low-level bacterial failures

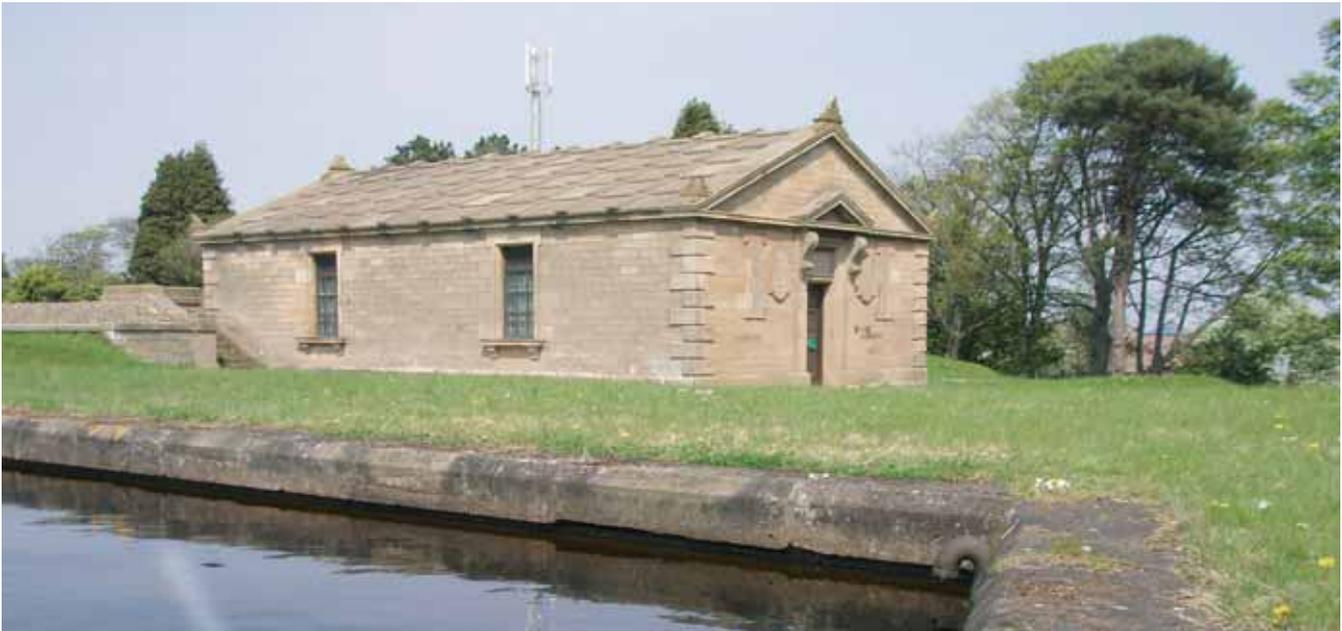
Alnwick clearwater repairs

The first phase of inspections and repairs was on the 'New Tank'. It was first drained down and then inspected. A large crack was found in one of the supporting brick arches, this crack and a number of other minor cracks were sealed by the specialist concrete repair contractor using a high pressure resin injection method.
