Seathwaite Tarn Reservoir

repairs to a remote reservoir in Cumbria

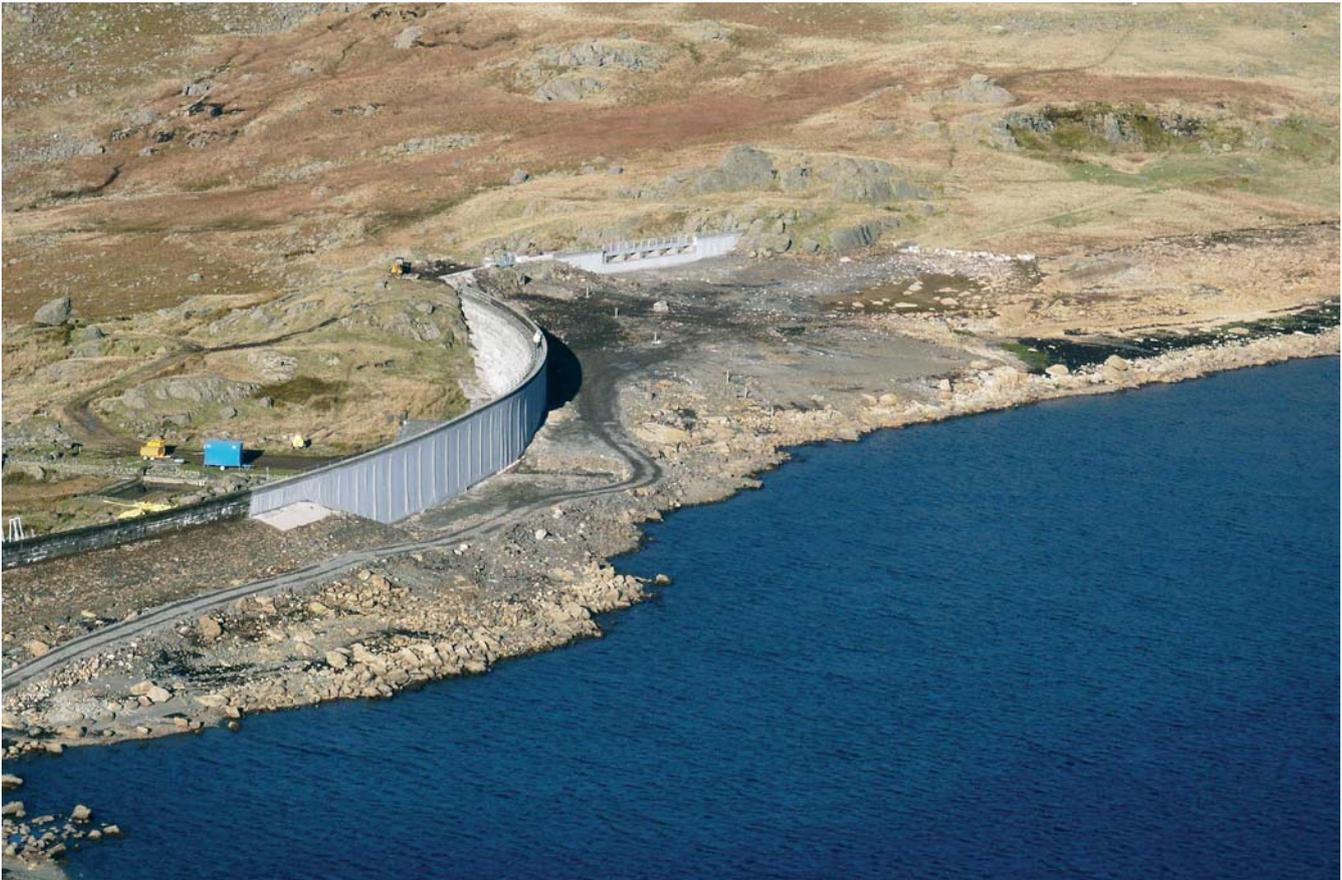
Aerial view, upstream face of concrete dam and auxiliary overflow showing temporary access and Carpi Membrane Courtesy of Eric Wright Civil Engineering Ltd and MWH

The remedial works on the upstream face included the installation of a PVC geocomposite membrane, geonet drainage layer and associated drainage system to the upstream face of the main dam and the auxiliary overflow. The geomembrane is sealed on the concrete face along the foundation line and on the parapet wall 300 mm above the crest level to cover the joint between the upstream face and the parapet wall. The geomembrane covers a total surface area of 1,100m².

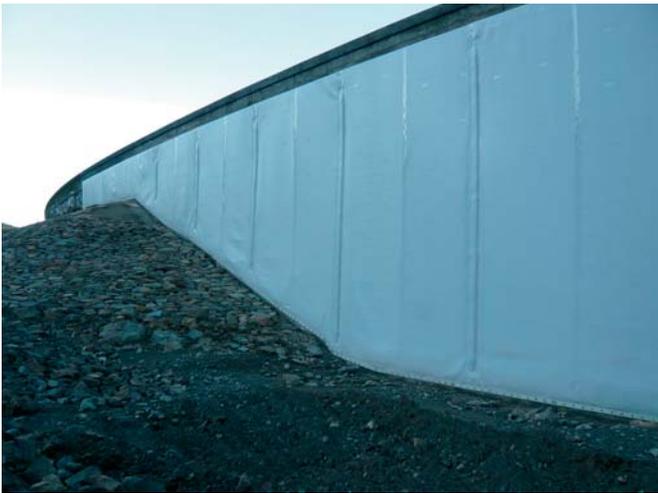
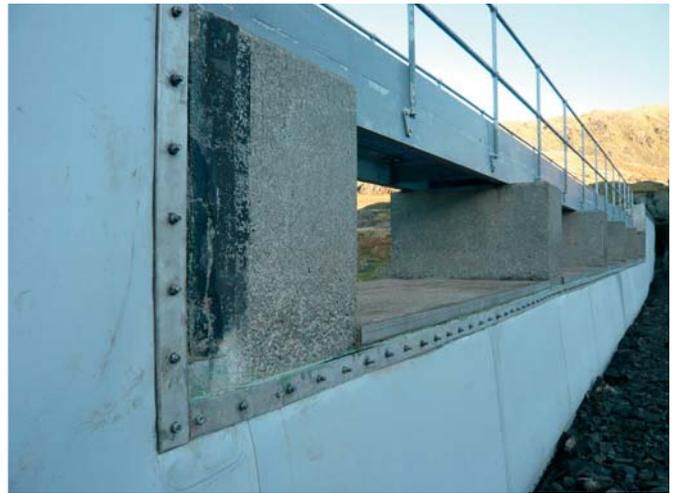
In addition to the poor condition of the downstream face, it was noted that there were numerous significant horizontal and vertical cracks on the upstream face, many filled with calcite. Finally, it was found that the wave wall was also in poor condition and it was noted that it does not reach 'high' ground at the left hand end of the dam.

Photos show new membrane on upstream face of concrete dam (left) and auxiliary overflow (right)

A Geomembrane drainage system was incorporated into the design to discharge water through 3 holes in the dam. Joints and cracks in the concrete were treated with an acrylic resin where the perimeter seal crosses the joint to prevent reservoir water bypassing the perimeter seal.

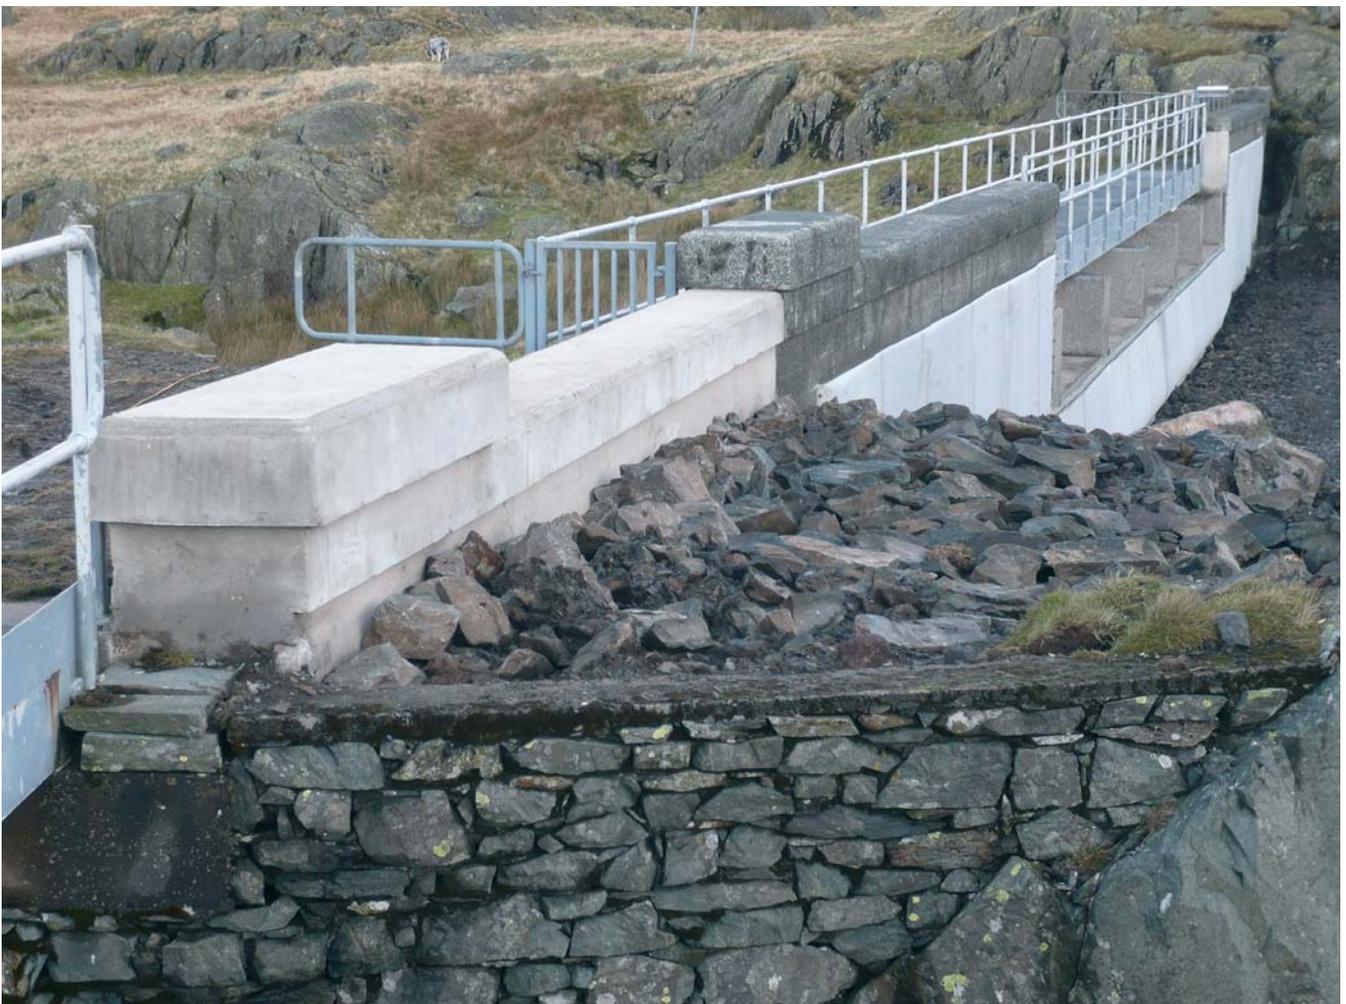
Modifications to auxiliary overflow structure and wave wall extension

A reinforced concrete wave wall was constructed to the same dimensions and levels as the existing but it extended into the high ground at the left and right ends of the dam.

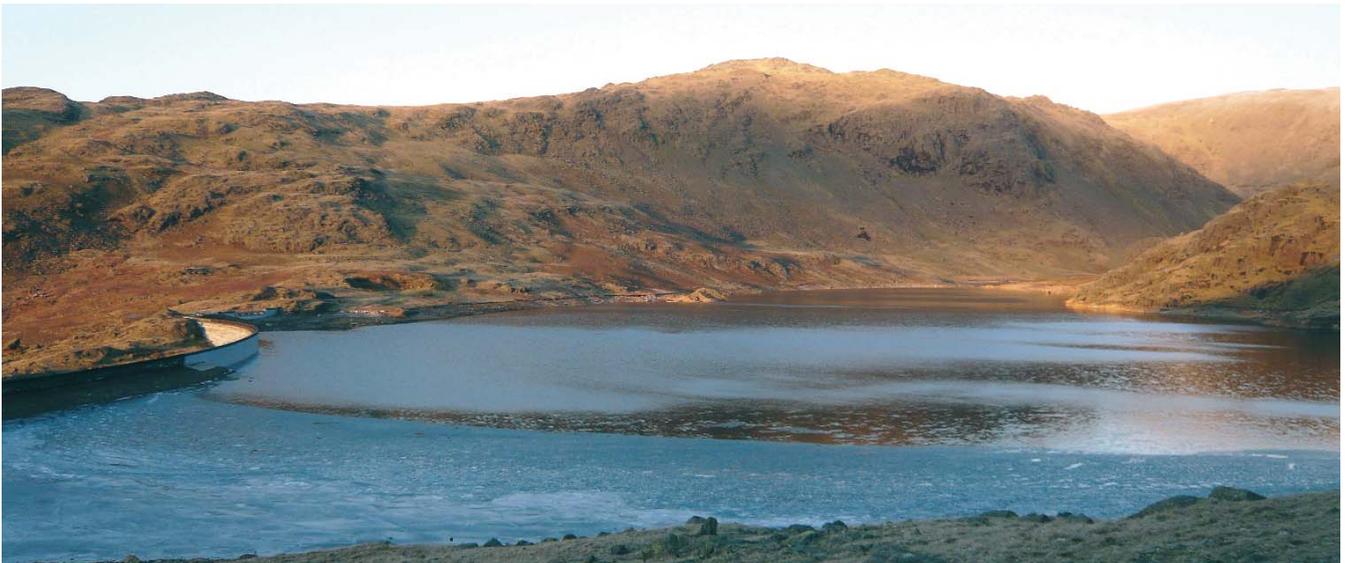
Seathwaite IR after completion of refurbishment
