Huxley Green

eliminating UID problem & reducing local flooding

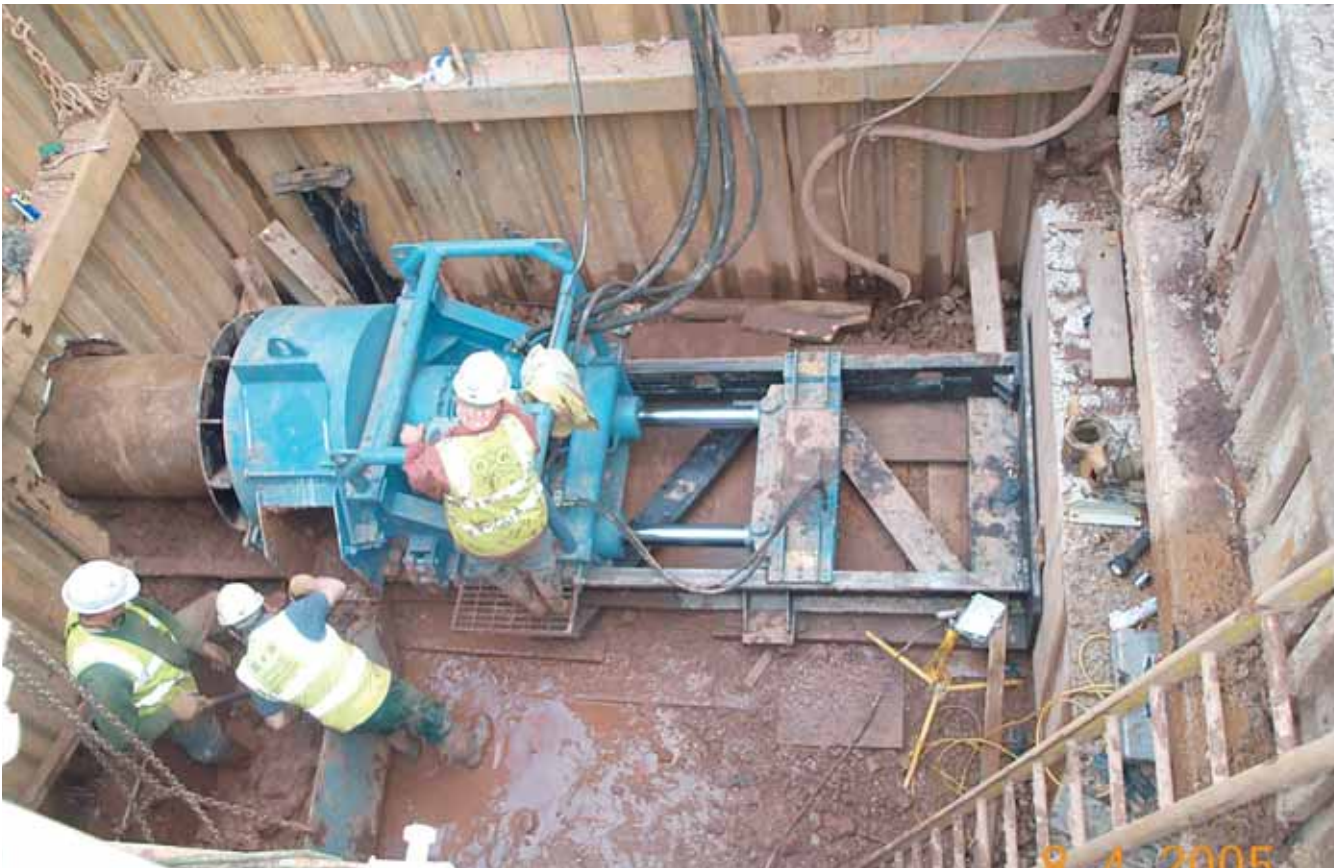
Huxley Green CSO under construction

The optimum solution was to construct diversionary pipework to a new CSO chamber with powered screening and build new outfall pipework taking flows to both the tributary and the brook

- * connections into the existing sewerage system;
- * open cut installation of single and twin concrete and ductile iron pipework, ranging in diameter from 400mm to 900mm;
- * construction of a large reinforced concrete (RC) chamber with powered screen, capable of treating flows up to 1,060 litres per second.
- * directional drilling of twin 600mm dia. pipes under the canal;
- * construction of 2 RC outfalls in the banks of the tributary & Brook;
- * construction of a number of standard and pressure tight manholes;
- * re-grading of land around the CSO structure to improve cover to pipes;
- * abandonment of existing CSO structure & ancillary pipework;
- * construction of permanent access road & installation of a fenced control kiosk and telemetry. ■
