Buxton Sewage Treatment Works

demolition of decommissioned STW & land reinstatement

by
Catherine Hitchen BSc (Hons), MSc, AIEMA

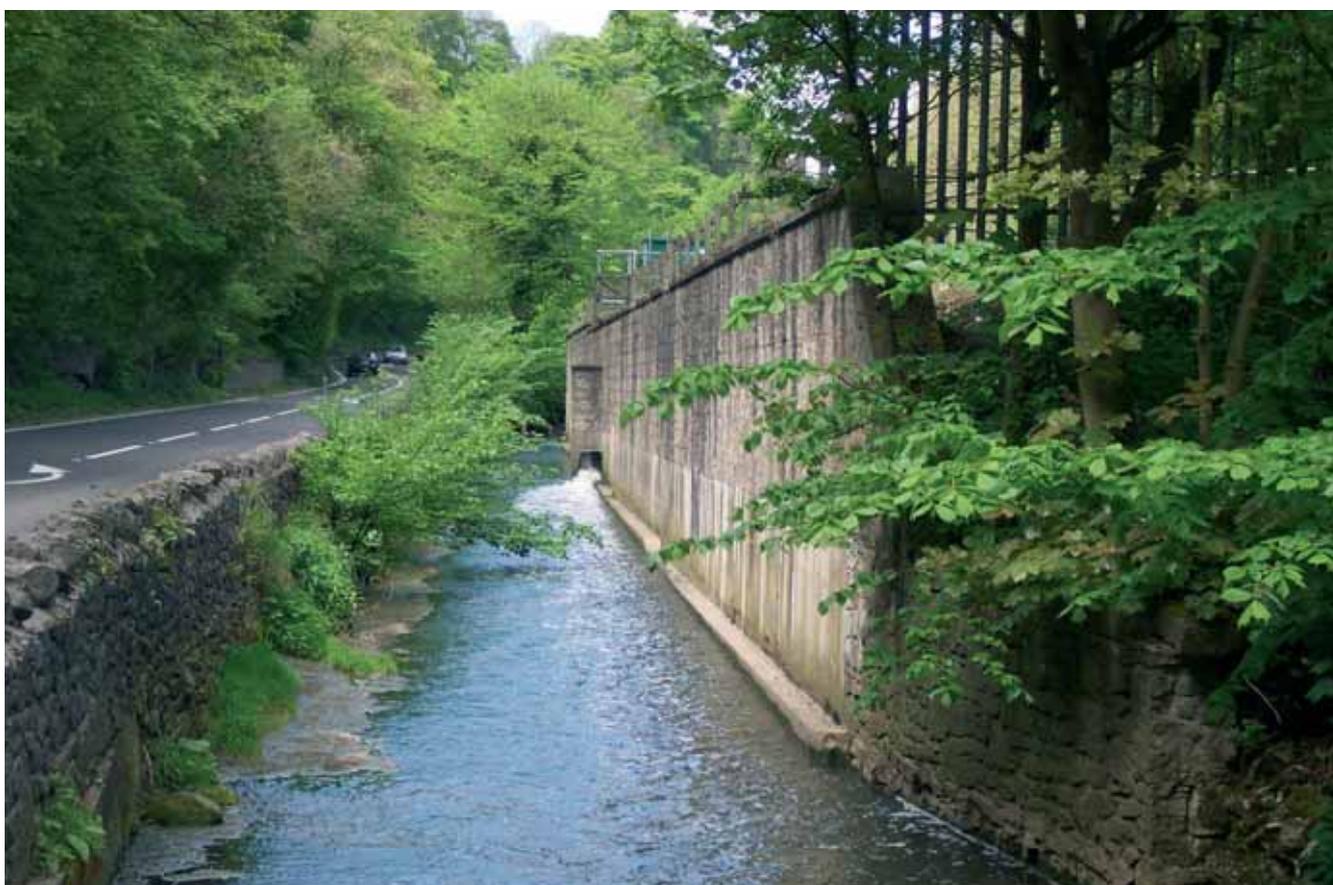
View of original site alongside River Wye

The filter beds extended over the River Wye, contained within a culvert. The river was to be returned to an open channel flow, unimpeded by the existing development, and the site was to be reinstated to a more natural landscape.

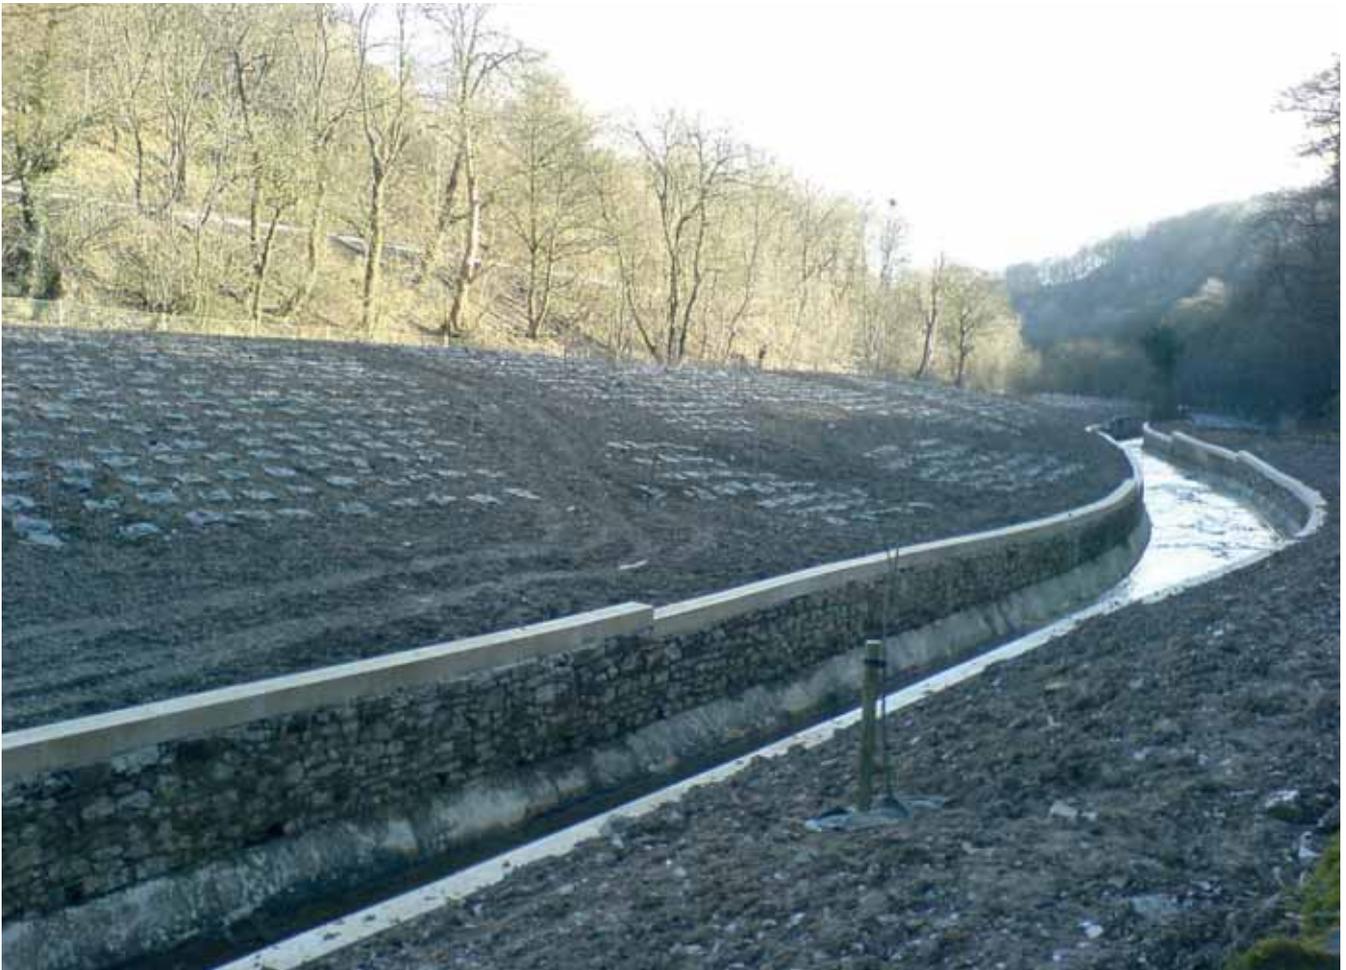
Job completed and beauty restored

To minimise vehicle movements and prevent disposal of re-usable waste, virtually all the filter media and inert demolition arisings were incorporated into the landscape profile of the site. These arisings were utilised as fill for the decommissioned humus tanks following a successful application for a waste management licence exemption. These works formed part of the overall Planning Consent for Buxton Sewage Treatment Works, therefore specific details of the site's finished visual aspect and ground levels had to be identified at a very early stage in the project.

Communication with the Derbyshire County Council Planning Department continued throughout the scheme. Additional to the original scope of works, as requested by the planners, the retaining wall marking the site boundary adjacent to the River was reduced in height by 1,5 metres. This made the site less visually obtrusive and the Planners were very happy with the result. The project was completed successfully within programme, planning and budget and no environmental or health and safety RIDDOR incidents occurred.■
