# Mid Kent Mains Renovation

## £18.5m scheme with a customer focus

by  
Justin Southwell CEng, Mice, MCIWEM

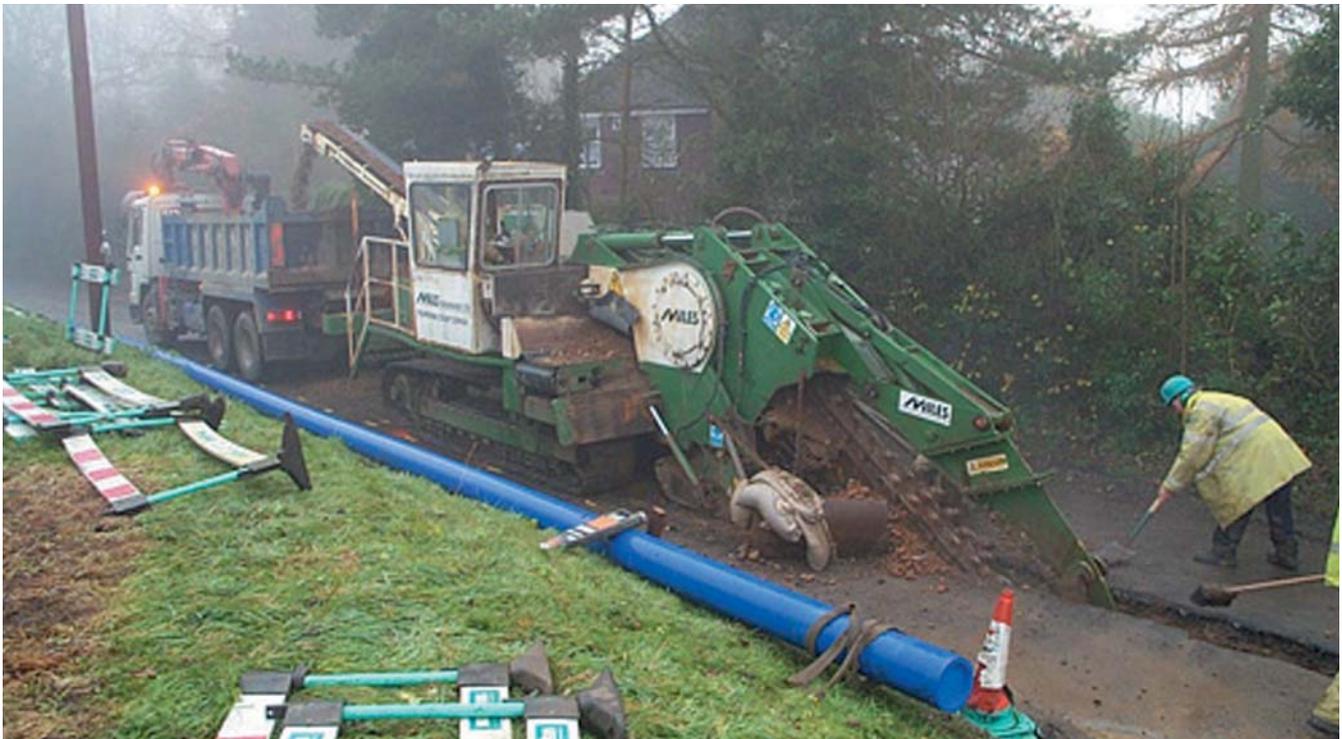
Mid Kent Water: Laying new mains, West Peckham

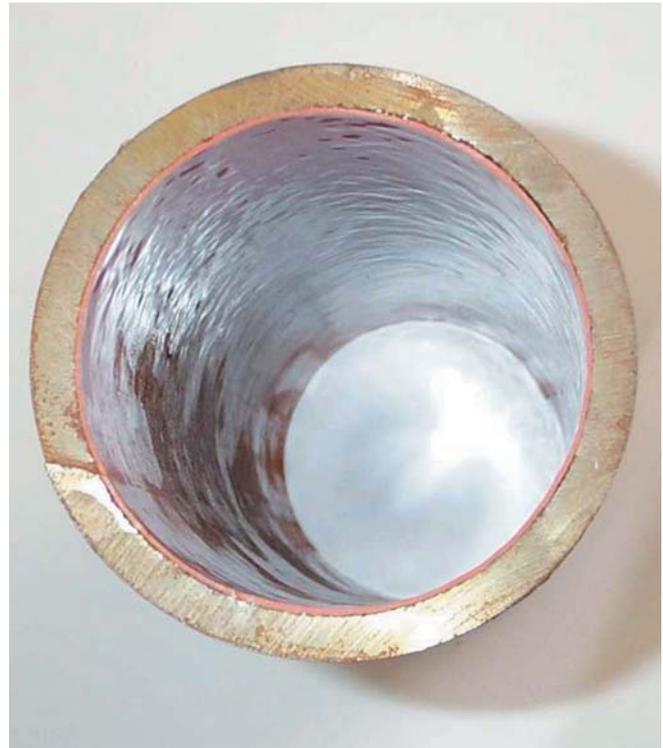
Lined mains

Because the strength of the main is often not in question the most cost effective solution is usually to scrape off internal deposits and spray apply an internal epoxy resin lining on site. Many contractors have developed specialist teams to carry out this work.

In conjunction with the water quality and customer survey data the condition of mains was assessed by analysis of burst history and inspection of cut-outs taken at strategic locations. The Waterfowl programme was used to identify mains which would benefit from replacement based on whole life costing. Epoxy lining was chosen for the majority of mains, but unserviceable mains were replaced with polyethylene pipe, using pipe bursting techniques to minimise cost and disruption. For operationally sensitive mains, rapid cure polymeric lining was used to allow return to service the same day.

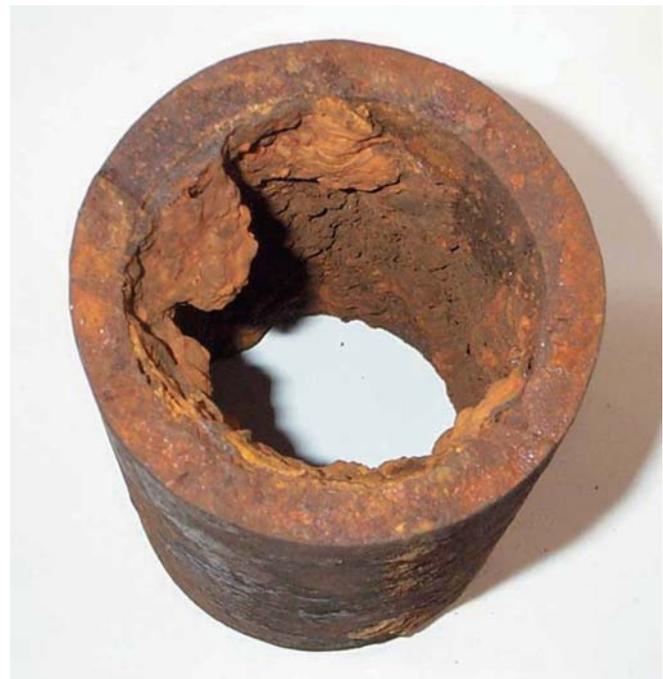
Unlined mains

**W**ho's for a glass of brown water? Not surprisingly, although it might be safe to drink, the supply of discoloured water does not sit well with the high standards expected of a 21st Century water industry. Nevertheless, this is what customers in many parts of the country have had to put up with from time to time in recent years. This phenomenon has its roots in our ageing infrastructure. Most water mains installed in the 19th and first part of the 20th century were made of cast iron, the durability of this material being demonstrated by the many Victorian water mains still giving good service in the majority of our towns and cities. However, the difficulty lies not in their durability but in the characteristic internal tuberculation occurring over time in such mains. Corrosion products build up inside the mains forming nodules which substantially reduce the hydraulic capacity of pipework and also lead to discolouration of the water supply when deposits are disturbed. This can happen with flow reversal or high velocities due to burst mains and peak demands.
